Hamilton Lelis Ito<sup>a\*</sup>, Jonas de Carvalho Gomes<sup>b</sup>

<sup>a</sup> Fundação de Apoio ao IPT, São Paulo-SP, Brasil

### *Abstract*

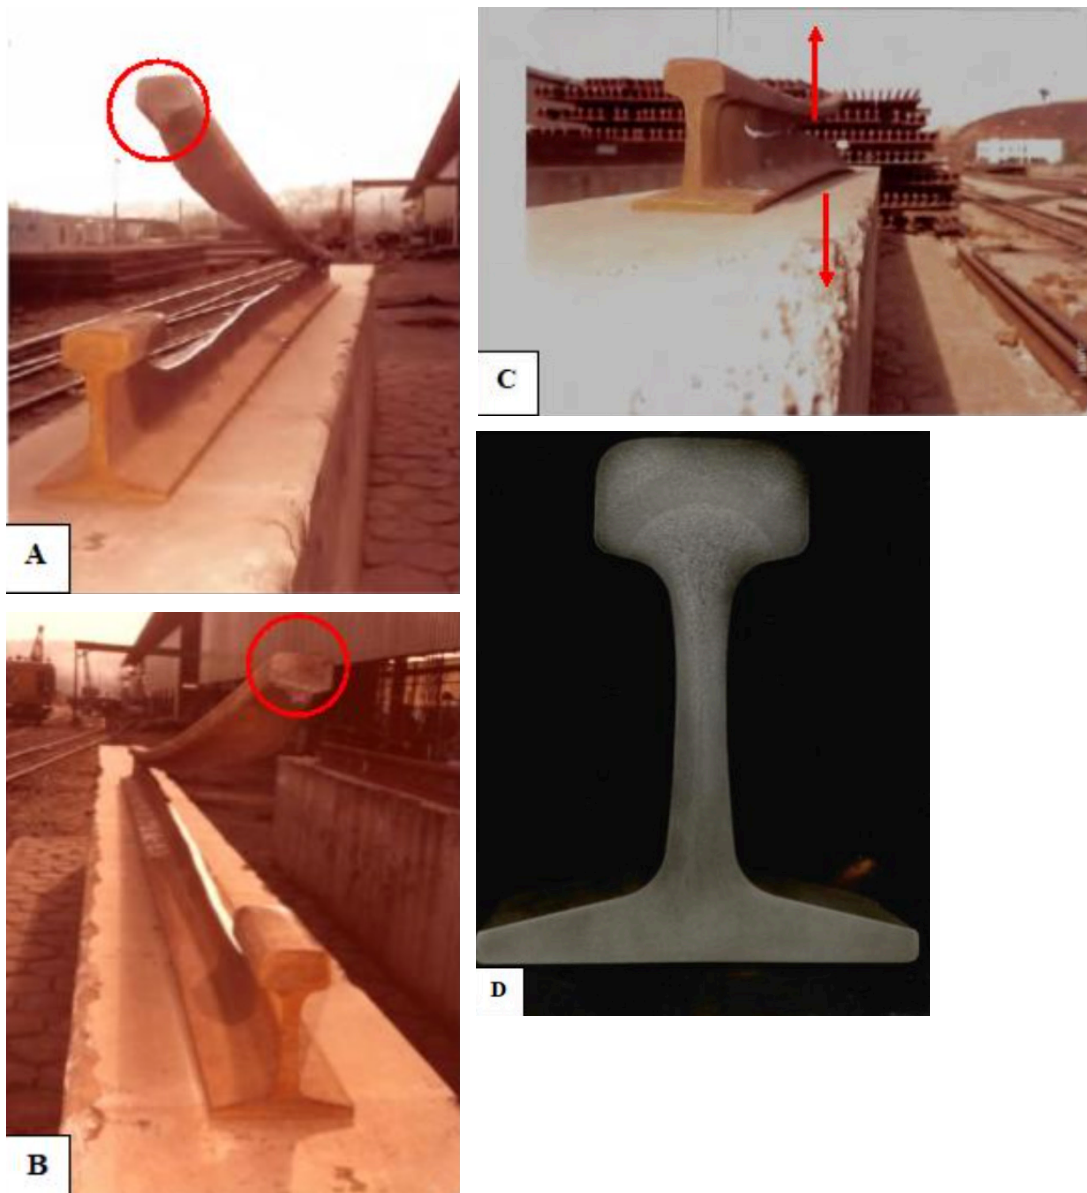
An astonishing longitudinal cracking along the rail web caused by residual stress during the assembling on the track requires to be reported to become unforgettable (INSTITUTO DE PESQUISAS TECNOLÓGICAS, 1981a). *Figure 1* shows a surface quench hardened rail that cracked during its assembling on the track. The rail was being transversally cut-off when suddenly it cracked longitudinally along the web in consequence of residual stress. Details (A) and (B) of *Figure 1* show the displacement of approximately 1 m, between the opposed surfaces of the crack in the cut region. The arrows in detail (C) point to the center of curvature acquired by the head and the rail base after the cracking. The displacement between the crack opposed surfaces and the curvature of the head and rail base occurred in consequence of the stress relieving of the residual stresses probably introduced during the heat treatment of the rail head and the cold straightening that followed it. Detail (D) presents the macrography of a transverse section of the rail, showing the depth of the local quench hardening of the head.

Figure -1 – Aspect of a rail cracked longitudinally along the web during a cut along the transverse section. (A) and (B) Observe the displacement occurred after the rail cracking. The region that was being cut is encircled in red. (C) Under this angle of view it is possible to observe the curvature occurred in the head and in the rail base which centers of curvature point to opposed directions. (D) Aspect of the macrostructure of a transverse section of the rail showing the heat-treated region of the rail head.

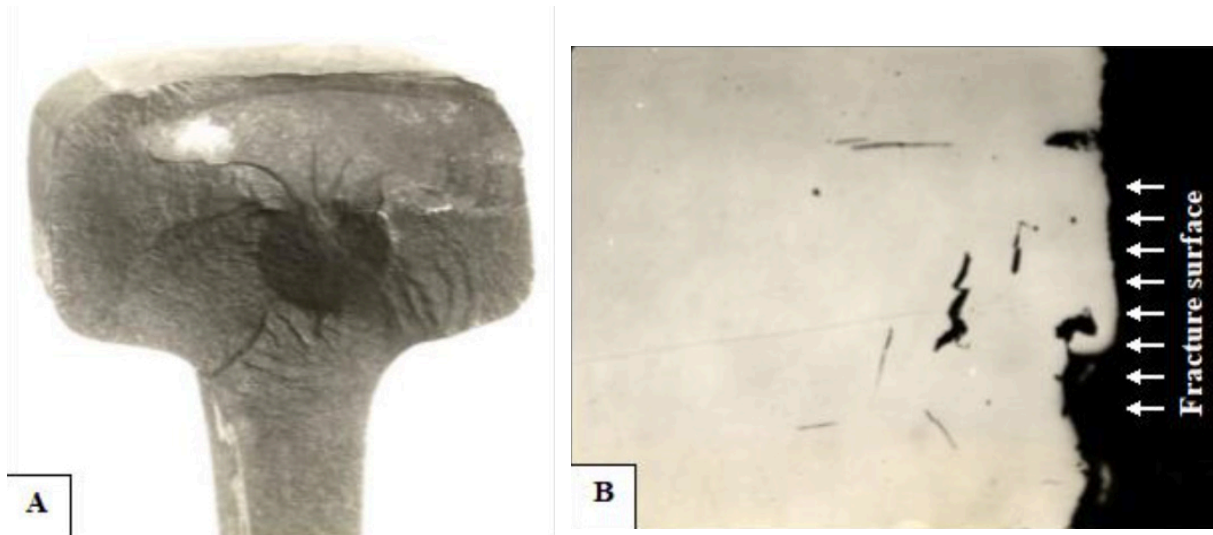
*Figure 2* shows a transversal fracture of a rail initiated in a consequence of hydrogen embrittlement due to deficient degassing during the steelmaking processing (INSTITUTO DE PESQUISAS TECNOLÓGICAS, 1981b). The metallographic analysis of a section approximately perpendicular to the dark

elliptical area of the fracture in the rail head, known as fish-eye (AMERICAN SOCIETY FOR METALS HANDBOOK COMMITTEE, 1975; POLUSKIN, 1956), observed in Figure 1 (A), presented hydrogen flakes showed in Figure 2 (B). The alternating vertical loading, applied to the rail due to the regular transit of trains caused fatigue propagation inside the head, from the fish-eye area. The fracture occurred when the crack reached its critical size.

Figure 2 – Aspect of a rail fractured transversally in consequence of hydrogen embrittlement. (A) The circular area in the rail head is known as fisheye occurs when hydrogen dissolved in steel in liquid state is not properly eliminated during the steel refining. (B) This photomicrography, taken from a rail longitudinal section passing through the fisheye region, presented internal cracks known as hydrogen flakes.

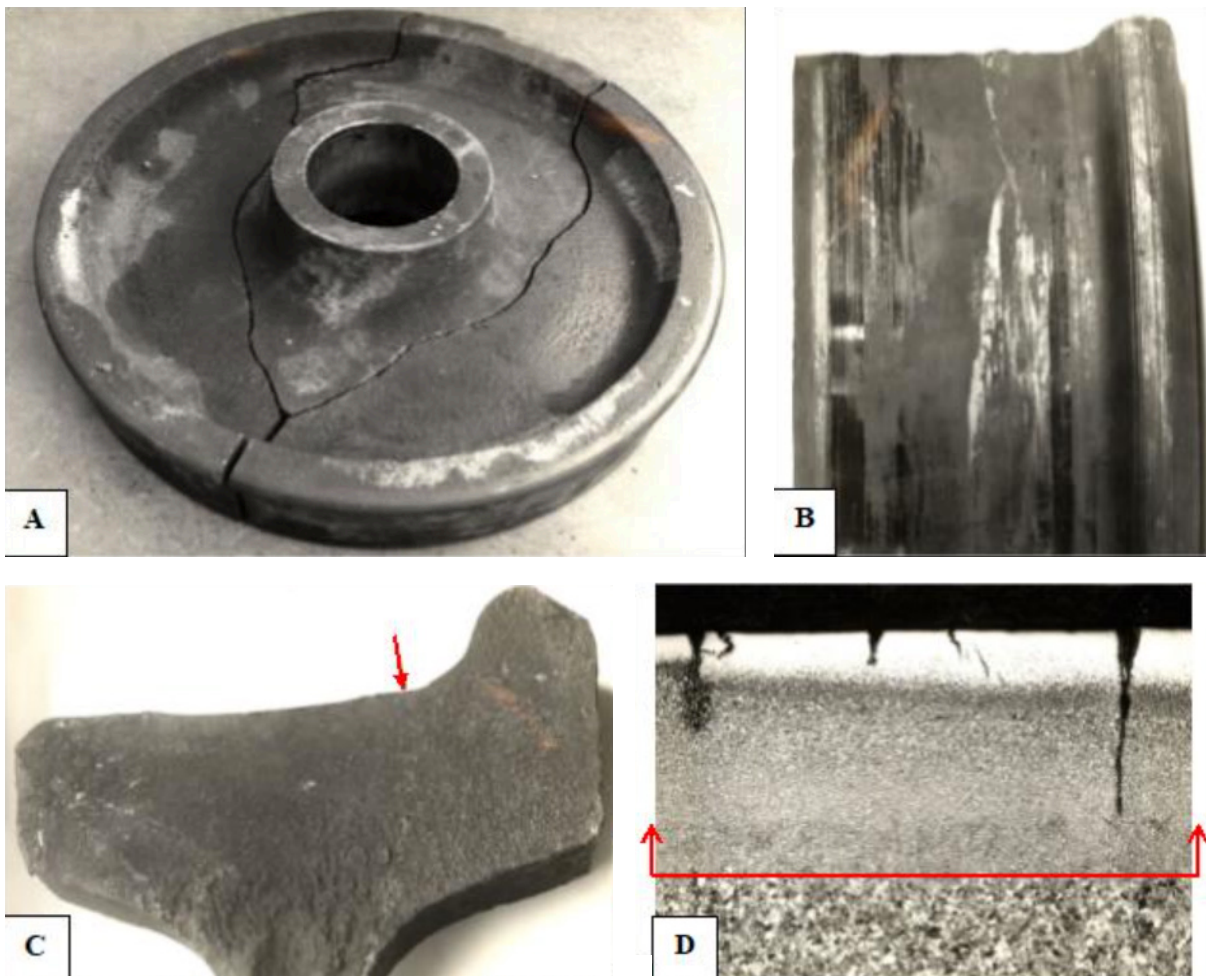
*Figure 3 presents a train wheel that fractured in consequence of thermal cracks on the rolling surface (INSTITUTO DE PESQUISAS TECNOLÓGICAS, 1981c). The wheel blocking occurred during braking led the wheel to slide on the track. The white layer, observed in Figure 3 (D), is constituted of untempered martensite caused by the temperature rise caused by the heat generated by the friction between the wheel surface and the track surface. The heating rose the temperature of the wheel surface up to the austenitic field. The quenching provided by the heat drained from the rolling surface to the wheel bulk caused cracking. The fracture initiated in one of these cracks.*

Figure 3 – (A) General aspect of the fractured wheel. The fracture began at the rolling surface, propagated along the rim and bifurcated around the hub. (B) Scratching can be observed on the wheel's rolling surface. (C) Aspect of the fracture surface. The arrow points to region of fracture initiation. (D) Microstructure of the material observed on a section perpendicular to the fracture surface. The region above the red line suffered microstructure change in a consequence of local heating generated by the friction between the wheel and the track. The whitish region is constituted of untempered martensite. The cracks initiated on the wheel surface due to thermal shock propagated in consequence of thermal fatigue and/or thermal-mechanical fatigue. Above the red line, there is the heat affected zone caused by the heat generated by friction between the wheel and the track. Below the red line, the material presents a regular microstructure for the wheel, constituted of pearlite. Magnification: 50X; etchant: Nital.

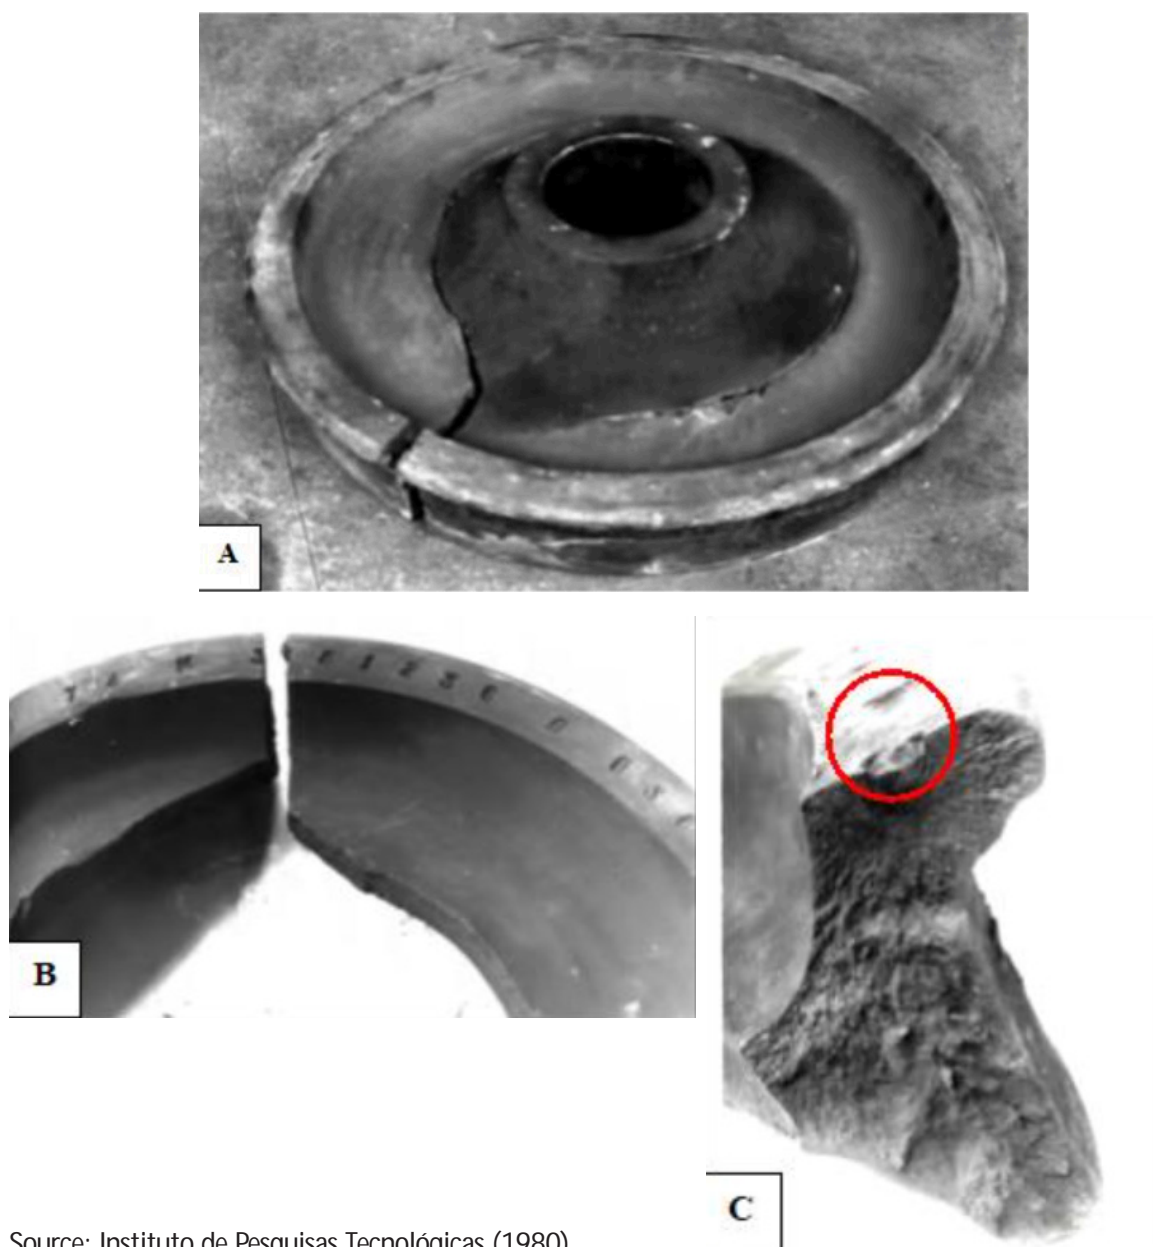
Figure 4 (A) presents a train wheel fractured as consequence of a manufacturing defect (INSTITUTO DE PESQUISAS TECNOLÓGICAS, 1980). The stress concentration caused by a too deep and sharp identification mark, observed in Figure 4 (B), provided conditions

Figure 4 – (A) General view of the fractured wheel. It can be observed that the hub detached from the wheel. (B) Aspect of rim side (flange) where the identification numbers and letters were stamped. It can be observed that the fracture passes through one of the identification marks. (C) The area outlined by the red circle shows fatigue beach marks spreading out from the tip of an identification mark. Radial marks typical of brittle fracture propagated from the fatigue area.

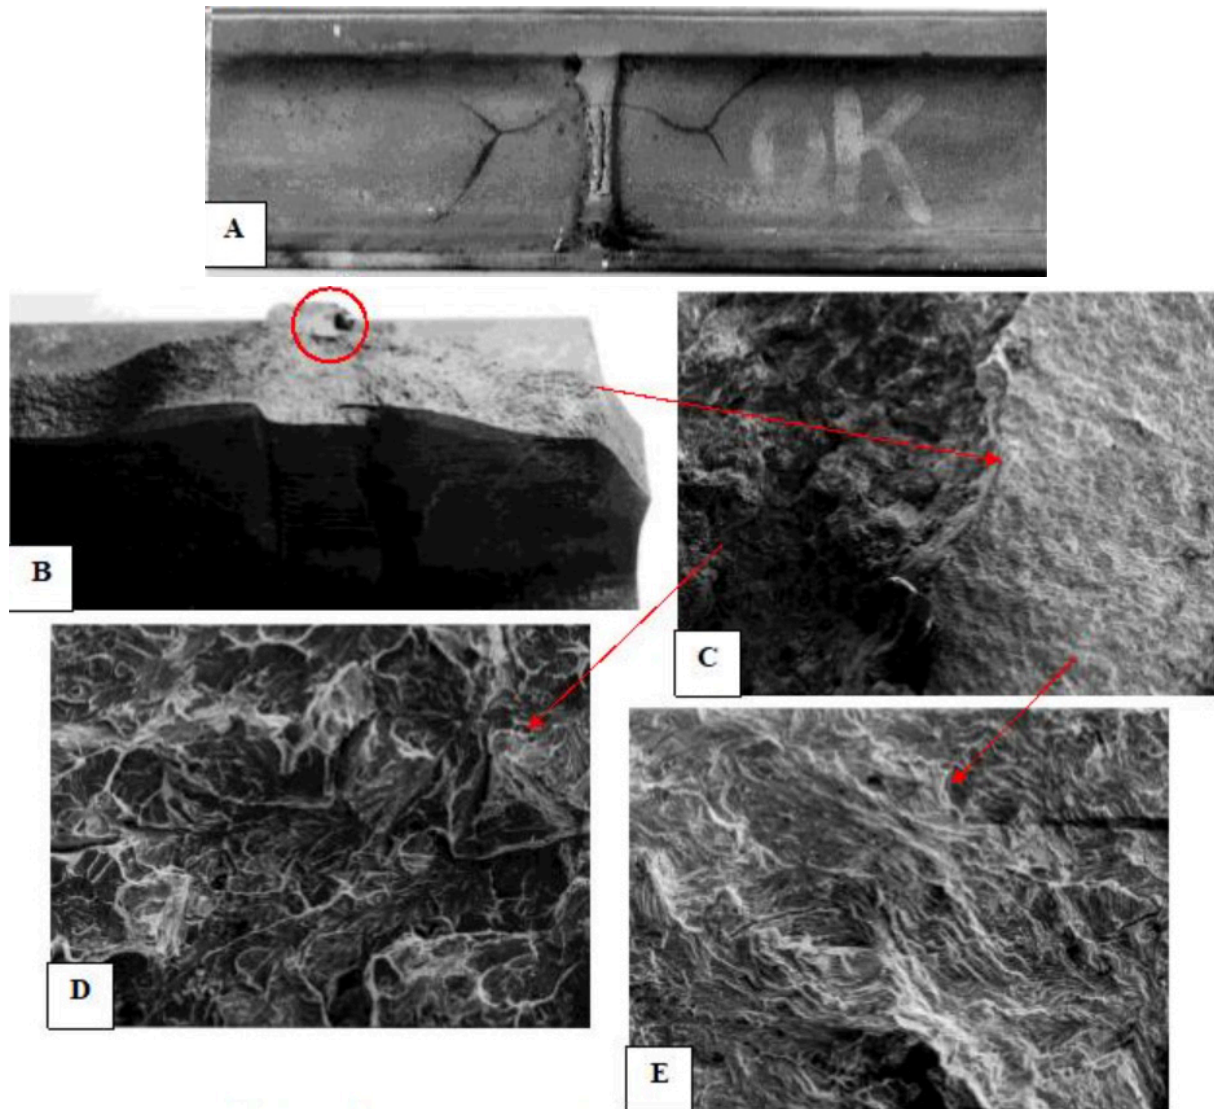
*Figure 5* (shows a rail butt weld joint cracked in service and removed from the tracks before fracturing (INSTITUTO DE PESQUISAS TECNOLÓGICAS, 1990). *Figure 5 (A)* shows the aspect of the joint after a liquid penetrant testing. It can be seen that the crack presents a pattern almost symmetrical in relation to the weld, in which a longitudinal crack splits in both of its ends. *Figure 5 (B)* shows the aspect of the exposed surface of the crack after the rail was properly cut. The region outlined by circle presents a defect in the weld flash that triggered the failure process. Firstly, a small fatigue crack initiated on the defect became unstable and suffered a sudden longitudinal propagation. The stresses responsible for this step were due to a combination of the stress caused by the lateral component of the load applied by the wheel flange on the track and the residual stress due to an inefficient or a lack of stress relieving after welding. The longitudinal propagation of the crack stopped when the stress relieving caused by its own propagation lead it to arrest. After this step, the rail became more compliant allowing the development of four fatigue cracks, two each side. *Figure 5 (C)* show the intersection between longitudinal crack and one of the two cracks that propagate in directions approximately at 45 degrees from the longitudinal crack. From *Figure 5 (C)* two arrows point to two photos of secondary electron image taken in a scanning electron microscope. *Figure 5 (D)* presents the microfractographic aspect of the surface of the longitudinal crack that shows cleavage, and *Figure 5 (E)* presents the microfractographic aspect of the slant crack that shows fatigue striations. The complete process can be described as the initiation of a small fatigue crack in a weld defect due to the lateral loading, applied by the wheel flange on the rail combined with the residual stress due to welding, lead the structure to reach the material's  $K_{Ic}$  generating the longitudinal crack. The longitudinal crack was arrested due to the relief of the residual stress due to the own cracking. After that, the torsion moment due to the lateral component of the load applied on the rail by the wheels caused two fatigue cracks initiated at each end of the longitudinal crack. This is a case in which no accident occurred because the crack was found during the ultrasonic inspection of the tracks before the rail fracturing. The solution of the problem required a better quality control of the weld to avoid and or to remove defects, the stress relieving after welding to reduce the possibility of cracking, and the periodical inspection of the rails by NDT to find eventual cracking occurred in service.

Figure 5 – (A) Overall view of the weld joint. The cracks were revealed by liquid penetrant. (B) Aspect of exposed surface of the horizontal crack and one slant crack. The circled region indicates a weld defect and around it a small smooth flat area of fatigue. The chevron marks observed on the longitudinal crack surface point to the weld region. (C) This picture taken with low magnification in a scanning electron microscope shows the corner between the longitudinal crack and the lower slant right crack. (D) Secondary electron image of the surface of the longitudinal crack showing cleavage. (E) Secondary electron image of the slant crack showing fatigue striations.

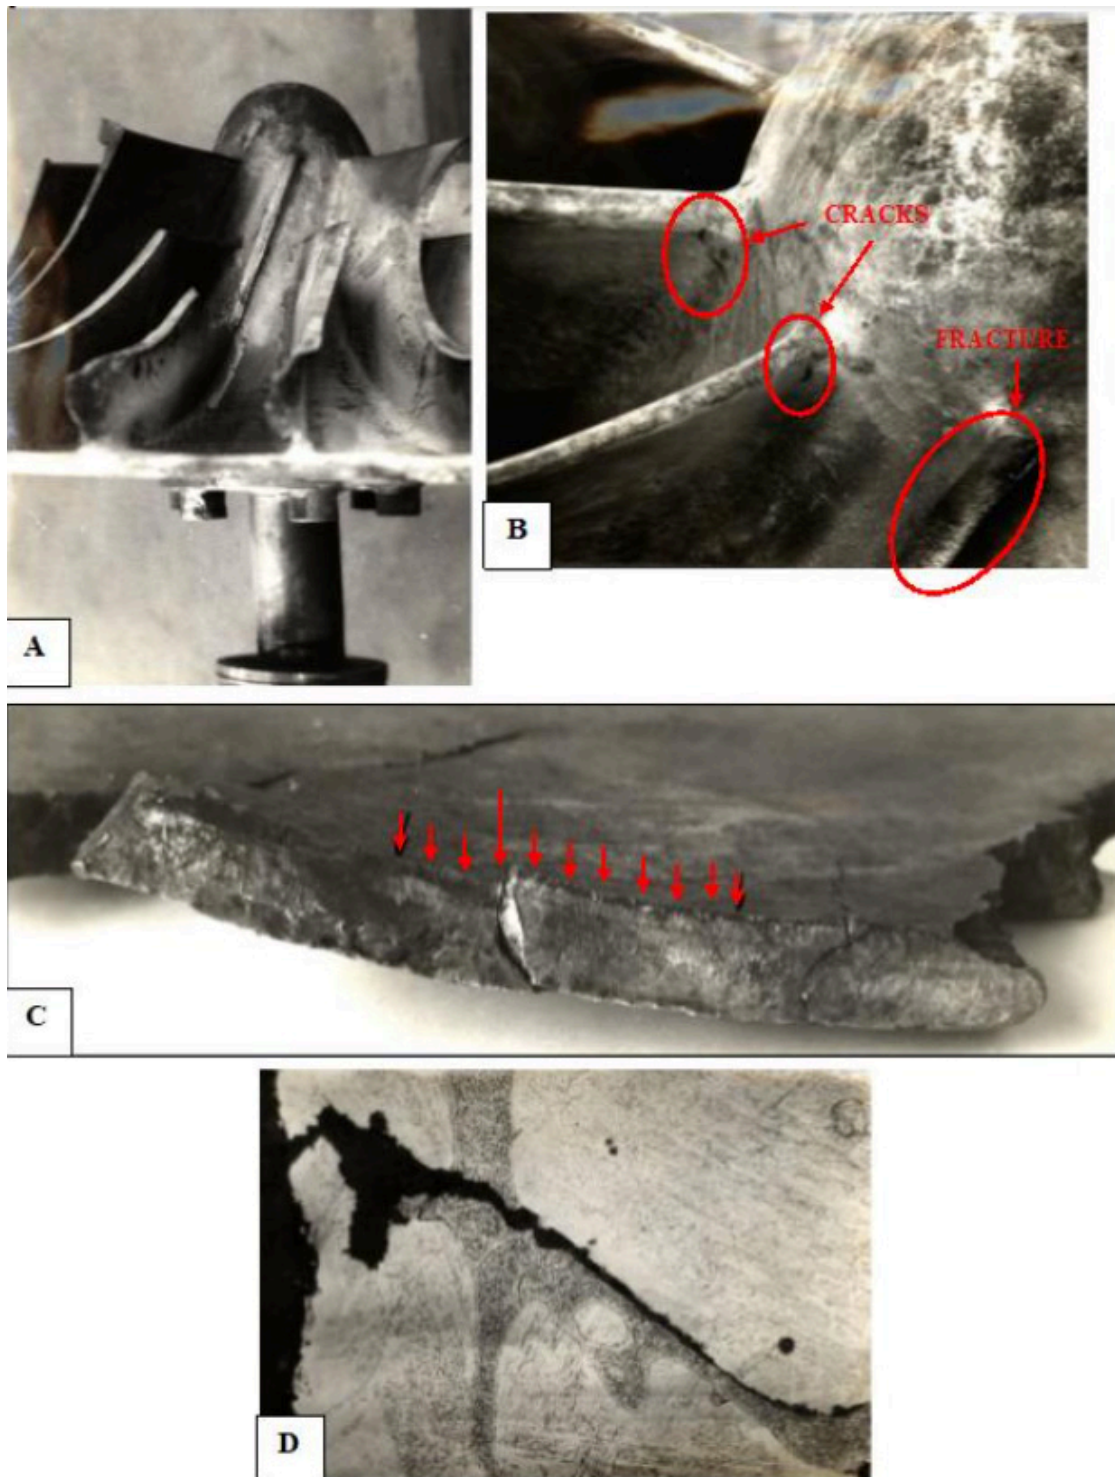
The rotor of the first stage of an oxygen plant turbo compressor of a steelmaking company, that had its blades fractured, worked under a severe environment due to air pollution (INSTITUTO DE PESQUISAS TECNOLÓGICAS, 1979).

The rotor was made of CB-7Cu, the cast version of the 17-4-PH precipitation hardening stainless steel. *Figure 6 (A)* shows an overall view of the rotor and in *Figure 6 (B)*; two cracks detected by a liquid penetrant test on the base of the blades near a fractured blade can be observed. *Figure 6 (C)*, which shows the fracture surface of a blade detached from the rotor, presents hatched marks typical of fatigue cracks initiated in stress concentration regions. *Figure 6 (D)* shows a photomicrography of a section passing through one crack initiated in a corrosion pit on the blade surface. The WDS analysis performed on the corrosion product in a JEOL JXA-50A Electron Probe Micro-analyzer revealed the presence of the elements oxygen (O), sulfur (S) and chlorine (Cl) inside the pit. The analysis of the water suspension prepared with 5 % of the solid residue removed from the inside of the rotor housing revealed 2.7 pH and chloride and sulfate concentration of 0.07 % and 50.2 %, respectively. The steelmaking plant was near the ocean, the air presented high concentration of SO<sub>2</sub> and, before being compressed, the air was simply dry filtered. The humidity and salt from the sea air, associated to SO<sub>2</sub>, generated in the blast furnace and in the coke plant, provided the condensation of a corrosive solution inside the compressing chamber during the compression. Since pitting corrosion is favored by the exposition of the steel to stagnant contaminated water, it probably occurred during periods in which the compressor was off. The resultant pits became stress raisers responsible for the several points of fatigue initiation indicated by the steps on the fracture surface presented in *Figure 6 (C)*.

Figure 6 – (A) General view of the rotor showing fractured blades. (B) Two cracks detected by liquid penetrant test on blades near a fractured blade. (C) Visual aspect of the fracture surface. The arrows point to hatched marks on the fracture surface typical of fatigue initiation at stress concentration points. The step pointed by the longer arrow indicates a region in which two fronts of fatigue propagation merged. (D) Aspect of the microstructure of a section that crosses a crack propagating from a corrosion pit.

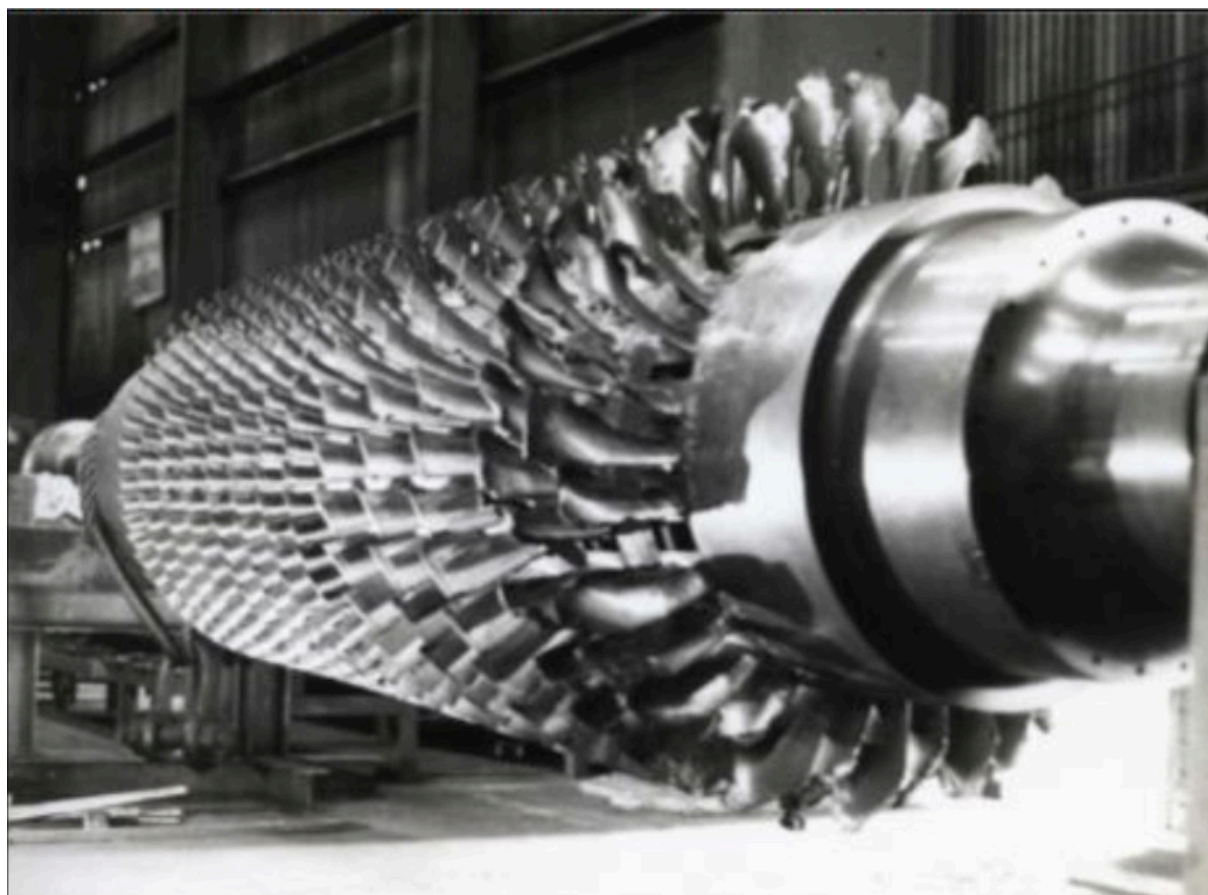
Figure 7 shows a general view of the compressor rotor after the failure. Six blades suffered fracture, three of the first stage, and three of the second stage of compression. The pieces of blades, detached after fracturing, hit other blades damaging not only most of the moving blades that were attached to the compressor shaft but also the stationary blades attached to the compressor case. Figure 8 shows the typical aspect of the fracture occurred in the blades.

Figure 7 – Overall aspect of the failed rotor of the axial compressor.

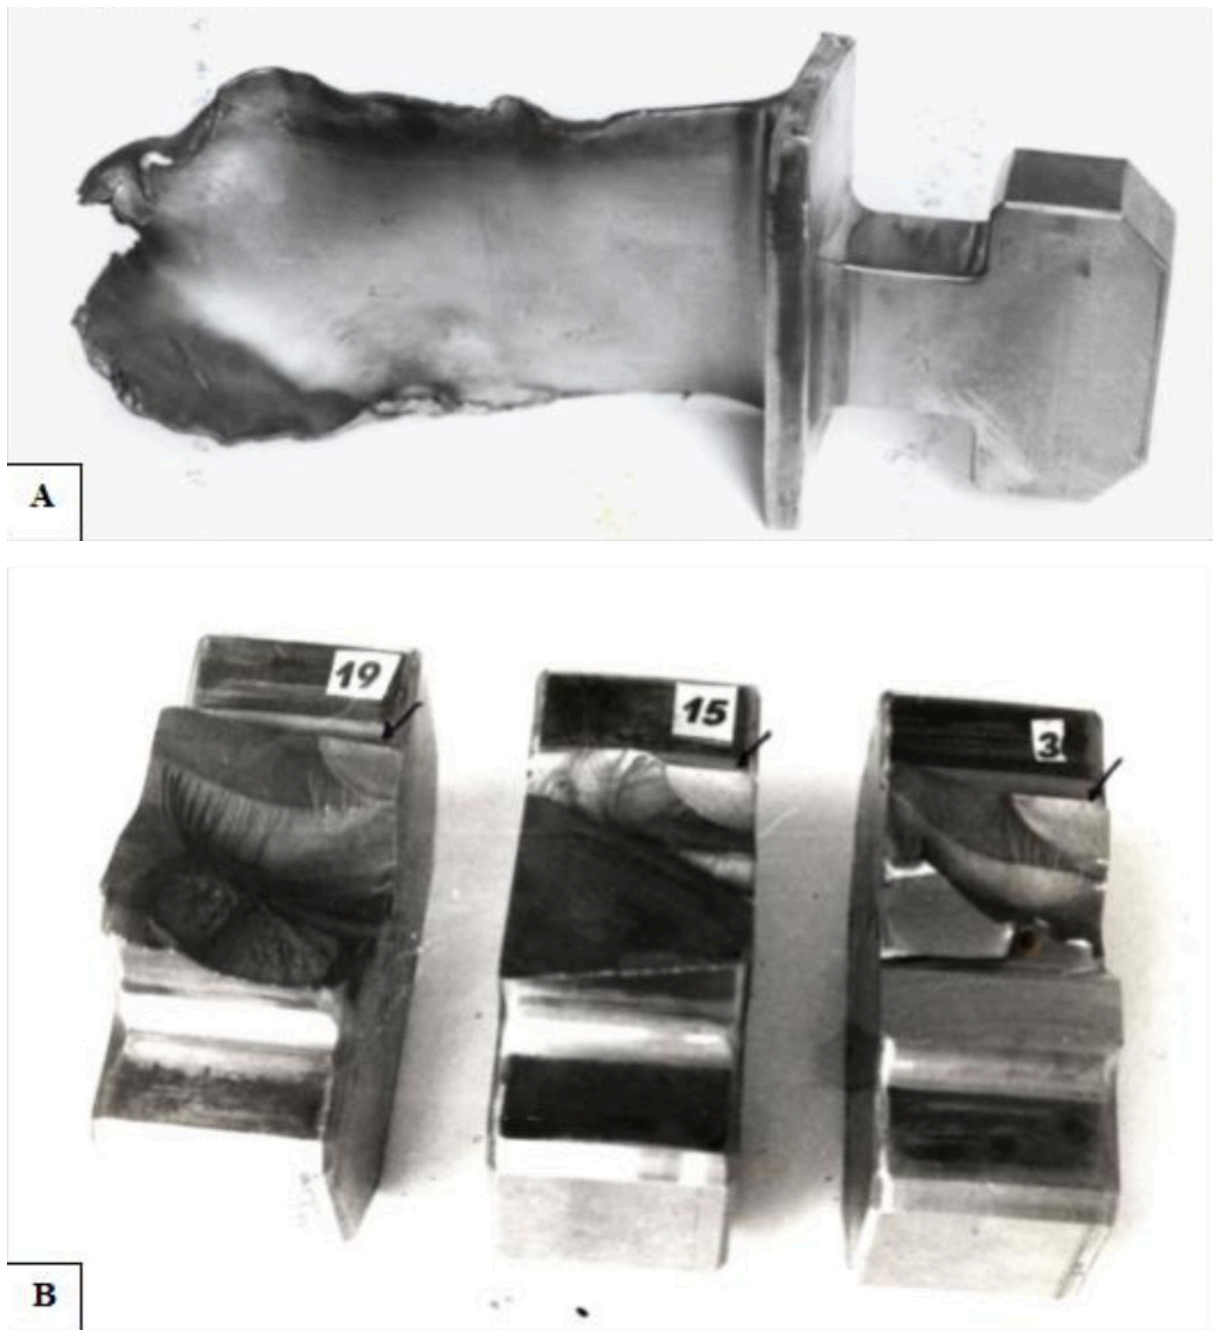
Figure – 8 – (A) Aspect of one blade of the first stage of the compressor damaged due to impact against fractured blades. (B) Aspect of fracture surface of three blades showing a similar pattern. The arrows point to the fracture of the three blades initiated near the corner between the neck and the fracture surface.

The examination of the fracture surfaces presented in Figure 8 revealed that the fracture occurred due to fatigue. Figure 9 (A) shows the typical aspect of the blade's neck surface that contacted the assembling groove of the rotor's shaft. The neck's surface was damaged by fretting, caused by micro movements between the blade and the shaft due to the vibration occurred in service. The same damaging was observed on the neck's surface of all

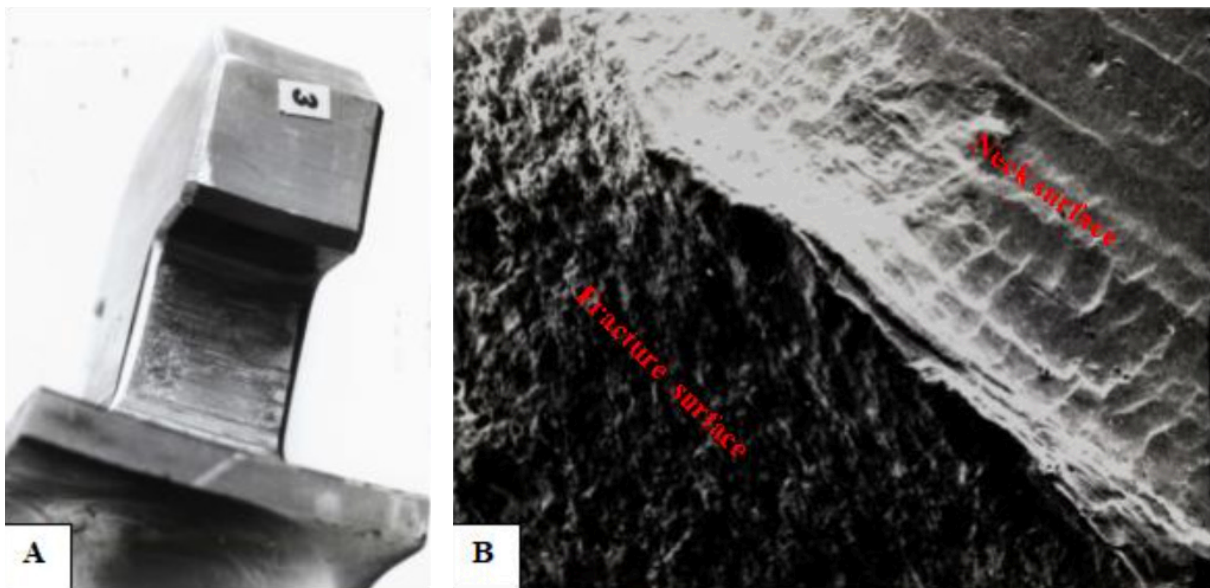
blades of stages I and II. Figure 9 (B) shows the typical low magnification secondary electron image of the intersection between the blade surface and the fracture surface. The damage caused by the friction on the blade surface is observed.

Figure 9 – (A) Aspect of a blade neck's surface showing scratching caused by friction against the shaft's groove surface. (B) Secondary electron SEM image showing the intersection between a fracture surface and a blade surface showing damage caused by friction on the neck surface.

*The major cause of the fracture was the too small clearance between the blade's neck surface and the shaft's groove surface which allowed the contact between the surfaces and consequently fretting. The stress responsible for the fatigue was due to vibration combined with the stress due to the radial load caused by the centrifugal force on the blades estimated in about 40 % of the yield stress of the material (520 MPa) for the blades of stage I of the compressor.*

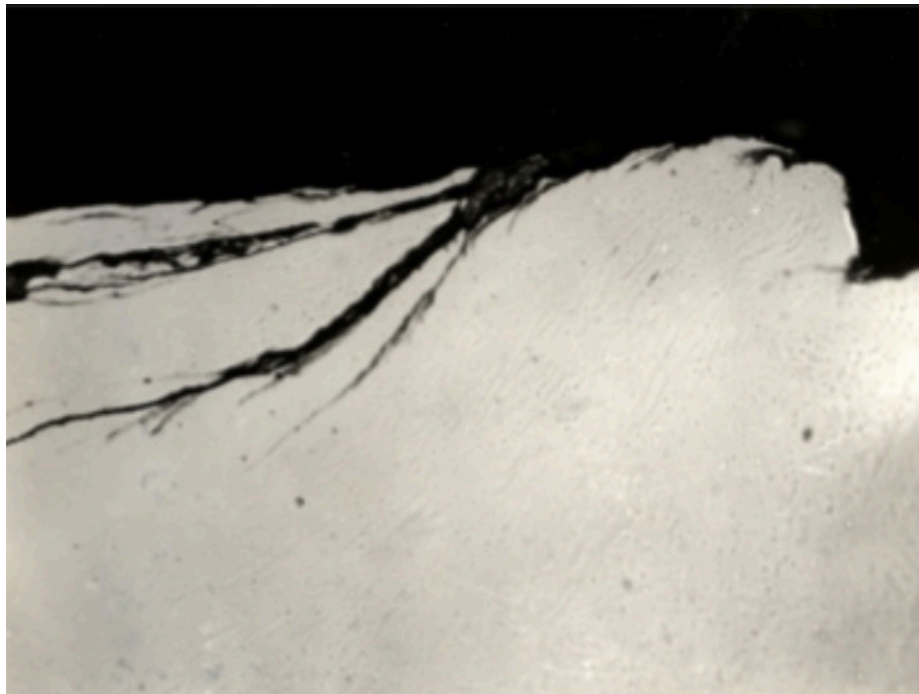
An unetched section, perpendicular to the corner between the fracture surface and the blade surface observed in Figure 9 (B), presented in Figure 10, shows deformation laps on the blade neck surface caused by fretting.

Figure 10 – Aspect of a section observed by optical microscope perpendicular to the corner between the fracture surface and the blade's neck showed in Figure 9 (B) showing deformation laps on the neck surface. Unetched. Magnification 500 X.

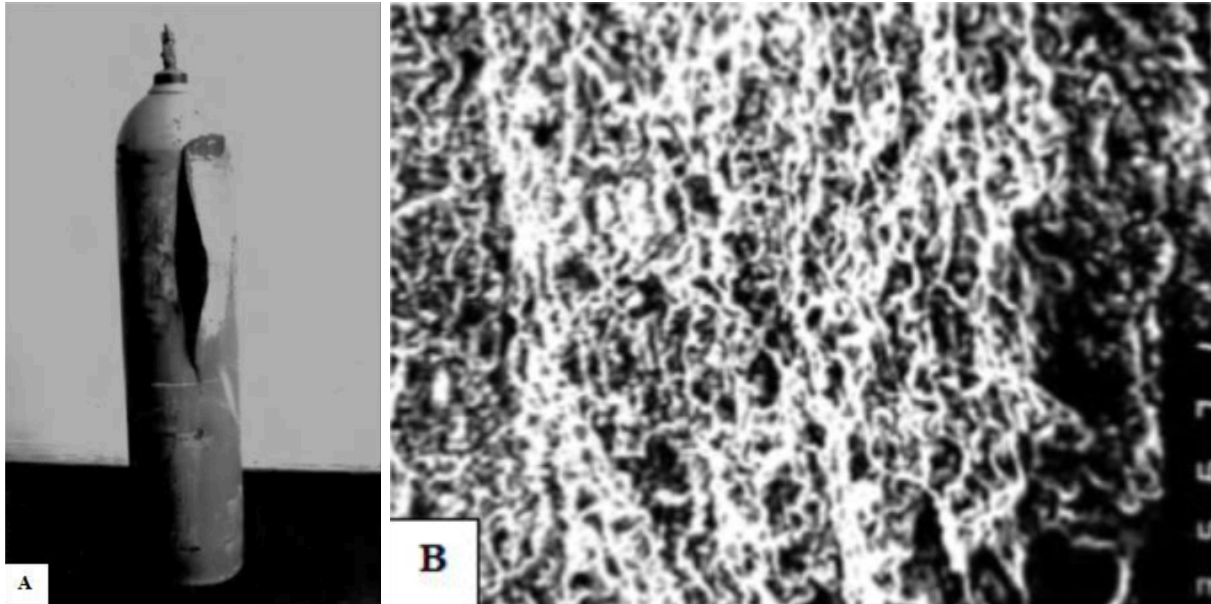
*Figure 11 (A)* presents a cylinder for chlorine gas that, after being exposed to sun during a summer-time day on a truck bucket, had a sudden rupture (INSTITUTO DE PESQUISAS TECNOLÓGICAS, 1991b). The inhalation of the gas by a person that was near the container led him to death. The material analysis did not reveal any quality problem in the cylinder and the fracture was 100 % ductile as can be observed by macroscopic deformation showed in *Figure 11 (A)*, and microscopically by the dimples revealed in a scanning electron microscope secondary electron image presented in *Figure 11 (B)*.

Figure 11 – (A) Aspect of the cylinder after rupture. It can be observed that the rupture was accompanied by macroscopic plastic deformation. (B) Secondary electron image of the fracture surface observed in a scanning electron microscope. The fracture surface is constituted only with dimples.

*The cylinder volume was 50 liters and was able to be filled up to 68 kg of chlorine. Chlorine is a substance that, as LPG and CO<sub>2</sub>, under pressure, can be kept liquefied at room temperature. At constant temperature, the pressure is maintained constant as long as there is gas and liquid simultaneously inside the container. The problem occurred because the cylinder was overloaded leading the cylinder to be totally filled with chlorine in a liquid state and it was equipped only with a fusible safety valve that should open when the temperature reached 70 °C. Because the cylinder was too full, it reached a rupture pressure much before the melting temperature of the fusible valve was reached. Calculations in the report demonstrated that an overload of 5 kg of chlorine would be enough to lead the cylinder to yield at 30 °C. Other cylinders of the same lot were found with more than 5 kg overload sustained the assumption that the failed cylinder was overloaded. The ductile fracture, the obedience of the material to the specifications and the absence of manufacturing defects in the container indicate that the material quality should not be responsible for the failure.*

*The use of an inappropriate safety valve, the overloading during the cylinder fill up and the heating caused by the sun exposure caused the cylinder rupture. The simple obedience to the limit loading and proper storage of the chlorine cylinder would have avoided the accident.*

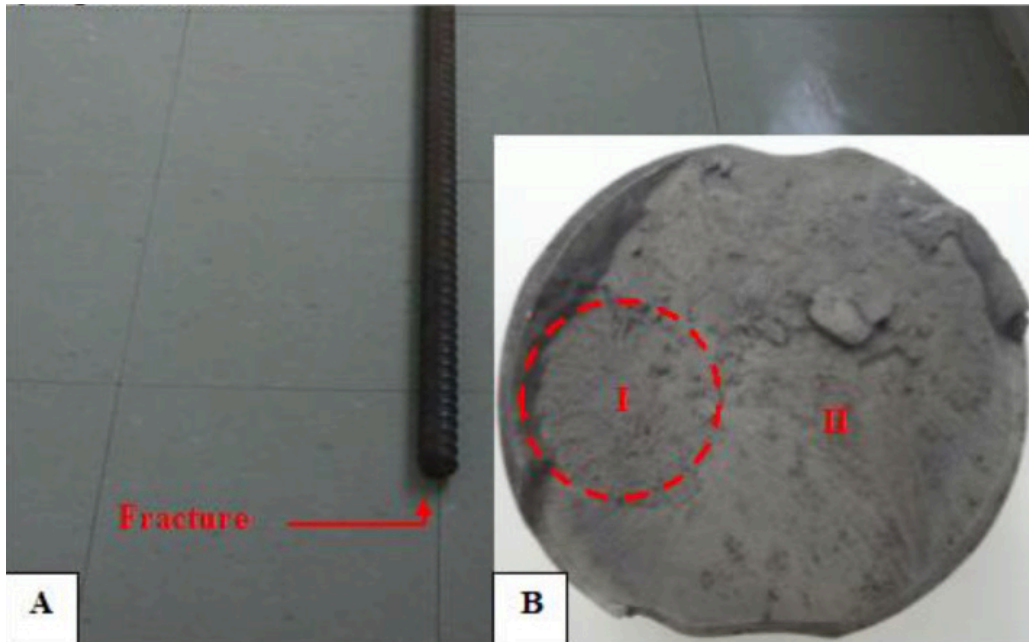
*Figure 12* shows a quenched and tempered rebar used for prestressing concrete that fractured due to hydrogen (INSTITUTO DE PESQUISAS TECNOLÓGICAS, 2014). The material chemical composition obeyed the specified by ISO 6934-1 [INTERNATIONAL ORGANIZATION FOR STANDARTIZATION, 1991], but the sulfur content was 0.006 %, or one order of magnitude below the maximum established by the standard (0.040 %). The fracture surface showed in *Figure 12 (B)* presents an almost circular area from which the fracture propagated.

Figure 12 – (A) Fractured rebar for pre-stressed concrete. (B) Aspect of the fracture surface. The circled area of the left side of the fracture outlines a fisheye due to hydrogen embrittlement.

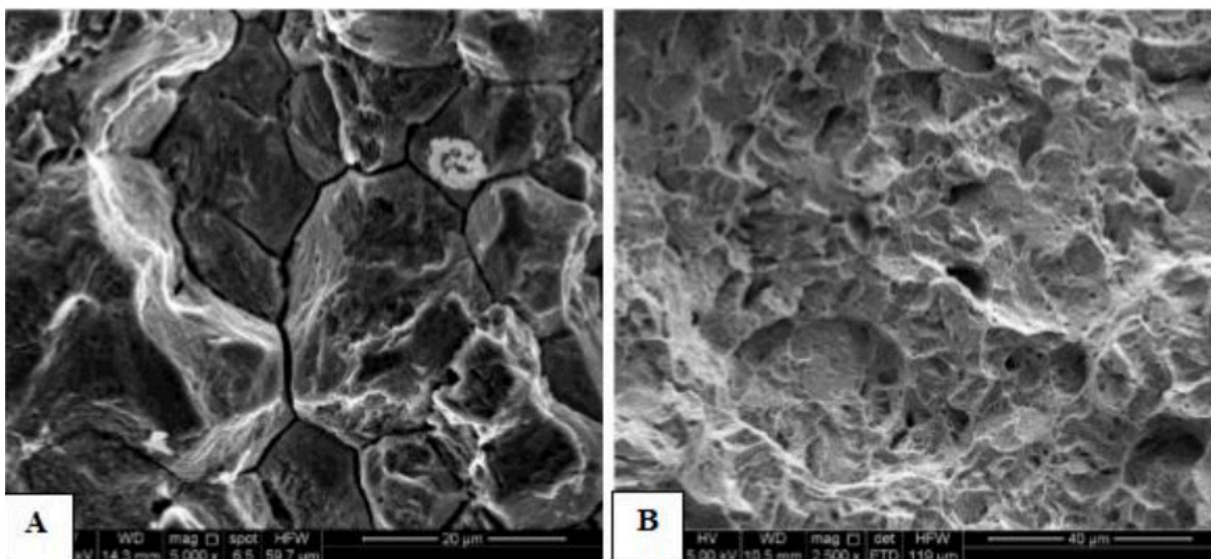
*Figure 13* shows secondary electron images (SEI) of Regions I (fracture initiation) and II (fracture propagation) indicated in *Figure 12 (B)*. *Figure 13 (A)* shows that the aspect of

the fracture of Region I is intergranular with secondary intergranular cracks, typical of hydrogen embrittlement. *Figure 13 (B)* shows the aspect of Region II of the fracture surface which is constituted of a mix of cleavage and dimples, sometimes, named quasi cleavage.

Figure 13 – (A) Aspect of fracture surface observed by scanning electron microscopy of Region I of Figure 10 showing intergranular fracture and secondary intergranular cracks. (B) Aspect of fractured surface observed by scanning electron microscopy of Region II of Figure 1. Mix of cleavage and dimples - quasi cleavage.

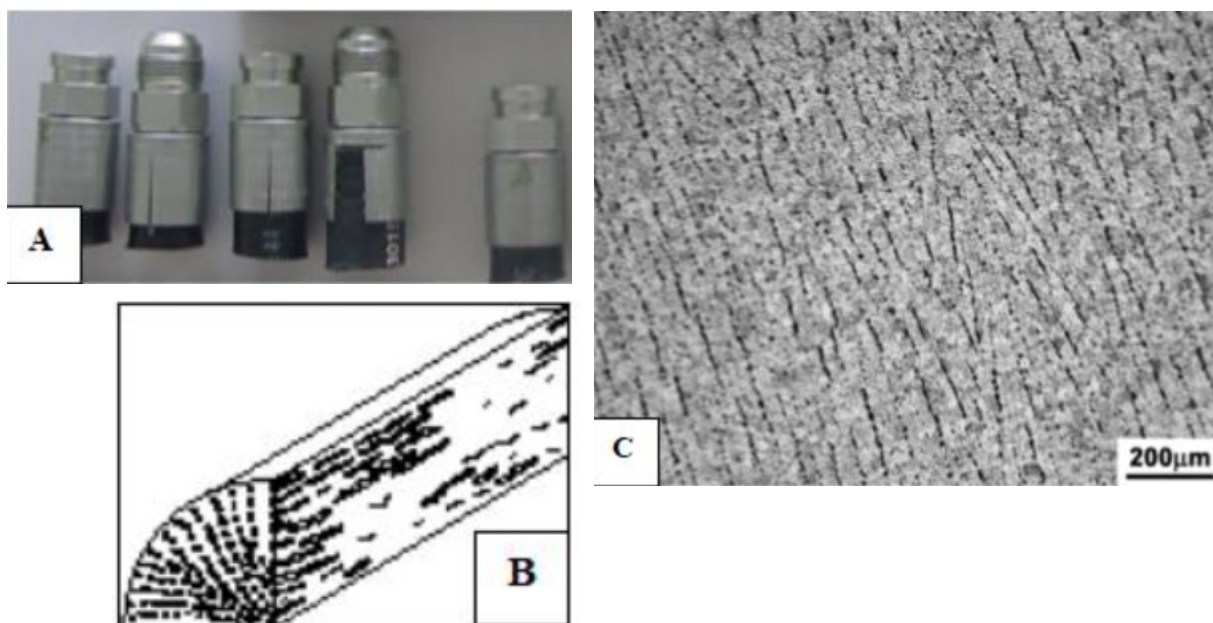
*Figure 14 shows another example of a material that had its implicit properties reduced by new processing (INSTITUTO DE PESQUISAS TECNOLÓGICAS, 2009). The parts observed in Figure 14 (A) were high pressure hose couplers. The regular process to make the couplers was to machine bars of resulfurized steel. The assembling operation by spiking the coupler on the hose used to be applied for a long time without so many cracking events.*

*When the manufacturer started to use continuous cast hot-rolled resulfurized steel bars, the cracking during the spiking of the couplers on the hoses began to become epidemic. The cause was the percentage of area reduction during the rolling of the new steelmaking process was not high enough to eliminate the radial orientation of the inclusions generated in the solidification as shown in Figure 14 (B). The hot-rolled bars passed in all tests long ago established according to standards. However, the new steelmaking process not only caused radial columnar grain grown along the radial direction, orienting the inclusions along the columnar grain boundaries but also was not able to break the orientation of the inclusions in the radial direction because the area reduction during hot rolling was not high enough for that. The inclusion orientation of bars produced according to the former process was predominantly longitudinal, whereas, on the new process, the inclusions were also oriented on the radial direction reducing the material's ductility in the direction perpendicular to the coupler radius.*

Figure 14 - (a) General view of some connectors. Observe longitudinal cracks in two of them. (b) Sketch showing the orientation of the sulfide inclusions in both longitudinal and transversal directions of the continuous cast hot rolled steel bar. (c) Photomicrography showing the orientation of the inclusions in the radial direction observed on the transverse section of the coupler.

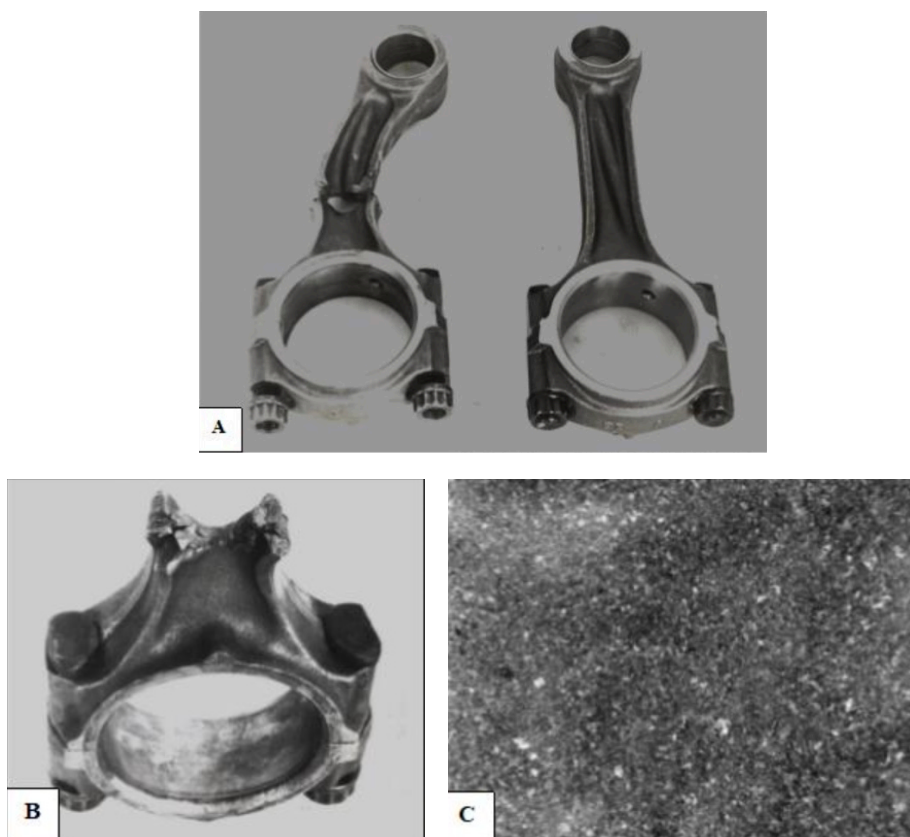
*Figure 15 (A) shows two connecting rods. On the left, one fractured after buckling due to a hydraulic block and, on the right, a new one (INSTITUTO DE PESQUISAS TECNOLÓGICAS, 1996). The fracture surface showed in Figure 15 (B) was too damaged to be analyzed by SEM. The material presented a microstructure constituted of tempered martensite as can be observed in Figure 15 (C) and hardness of 250 HB which was according to the specifications.*

Figure 15 – (A) Aspect of two pickup truck connecting rods. The one on the left fractured after buckling due to a hydraulic block and the one on the right was new. The fracture surfaces do not match perfectly because after the fracture the engine kept running for some time damaging them. (B) View of the fracture surface. (C) The microstructure of the material is tempered martensite.

To avoid hydraulic block, vehicles designed to cross over water streams (normally SUV's and trucks), besides four-wheel-drive, should have the air filter and the exit end of exhaust gases pipe positioned at the vehicle top level.
